Analysis of Soil at a Flooding Site in Avon, New York

Maddy Waldock and Katie Meerdink, Department of Geological Sciences, SUNY Geneseo,
1 College Circle, Geneseo NY 14454, mw32@geneseo.edu, kem35@geneseo.edu

Abstract

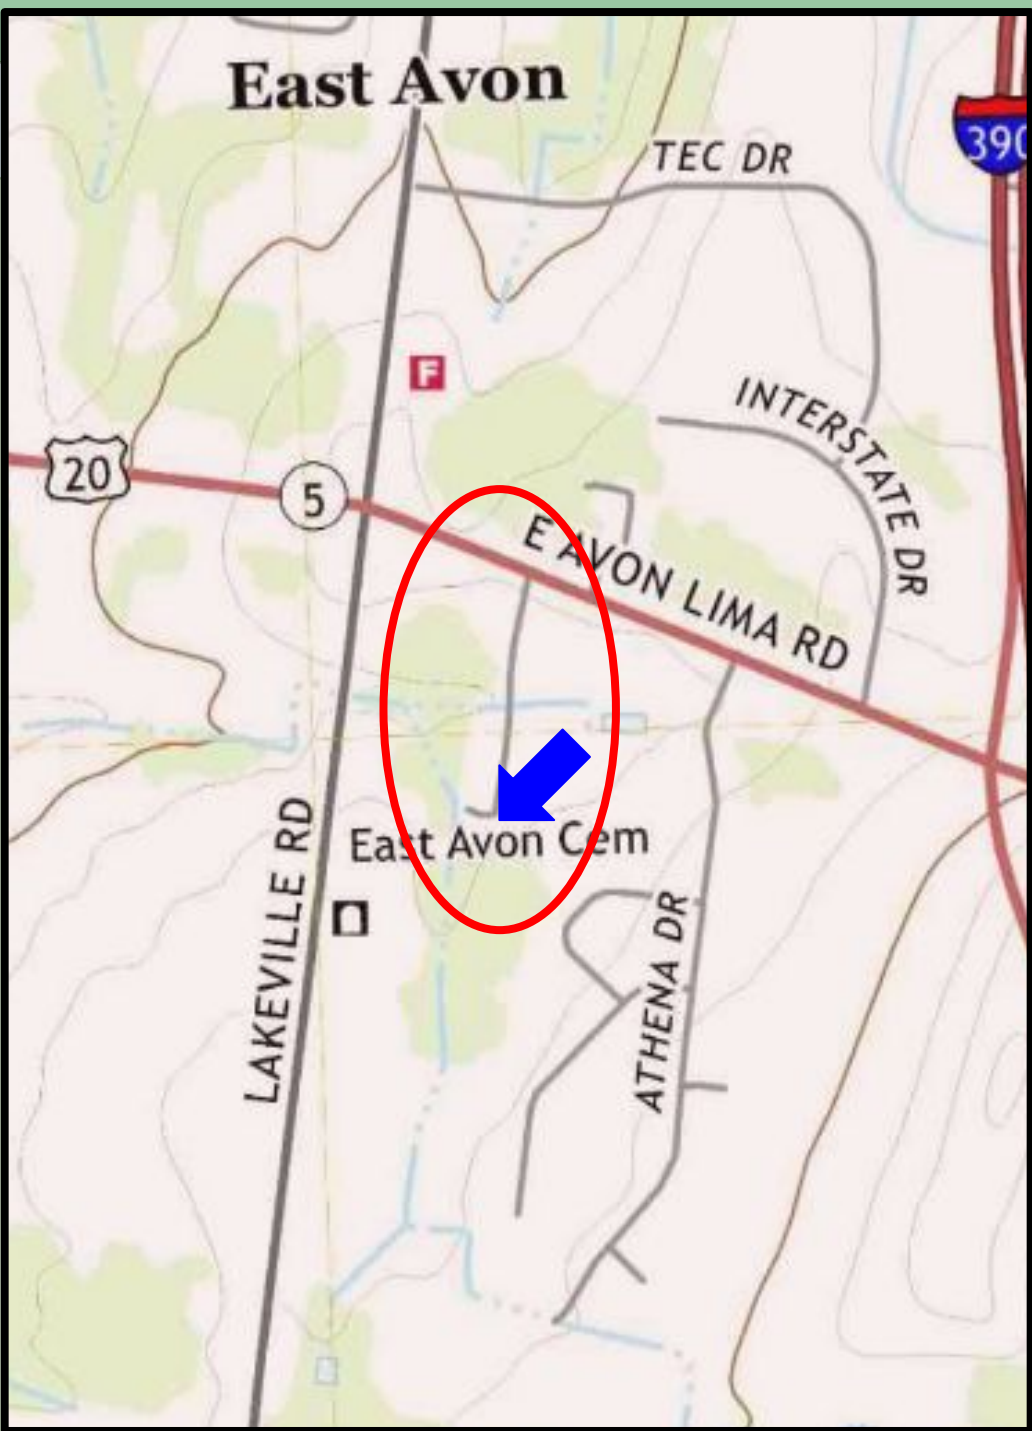
Figure 1: Map of East Avon. Red circle highlights the private road. Blue arrow represents area of study (Caltopo, 2020).

Nune Park is a mobile home community built in the 80's in a heavily glaciated area in East Avon, New York (Fig. 1). In recent years the park has experienced significant flooding events with stagnant water collecting in yards for weeks (Fig. 2). Flooding has caused damage to the foundations of homes, resulting in some trailers becoming unlevel and sinking into the ground. It has also caused significant damage to the road and homeowners walkways. Prior attempts have been made to mitigate the flooding but none have been successful.

The specific area of interest is on the east side, at the end of the road (Fig. 1). Nearby, a stream crosses the road, flowing from east to west (Fig. 1). A second stream is located to the west of the road and flows northward until it joins the other stream (Fig. 3).

The natural gradient of the area was shallowly sloping towards the stream (Fig. 1). Building of the road and the nearby neighborhood is likely to have impacted the local water drainage. Most notably, the flooding events began with the construction of the Royal Springs neighborhood (Fig. 6 & 7) from former farmland. This area is directly southeast of Nune Park and is located at a higher elevation, therefore, the surface runoff from this region (see A in Fig. 6) flows towards the study area (Figs 1 & 6). Residential areas have a higher impervious surface area than farmland, meaning that rainwater does not penetrate into the ground as easily (OEHH, 2020). This means that more water is traveling along the surface into Nune Park after Royal Springs was built and therefore is contributing heavily to the flooding.

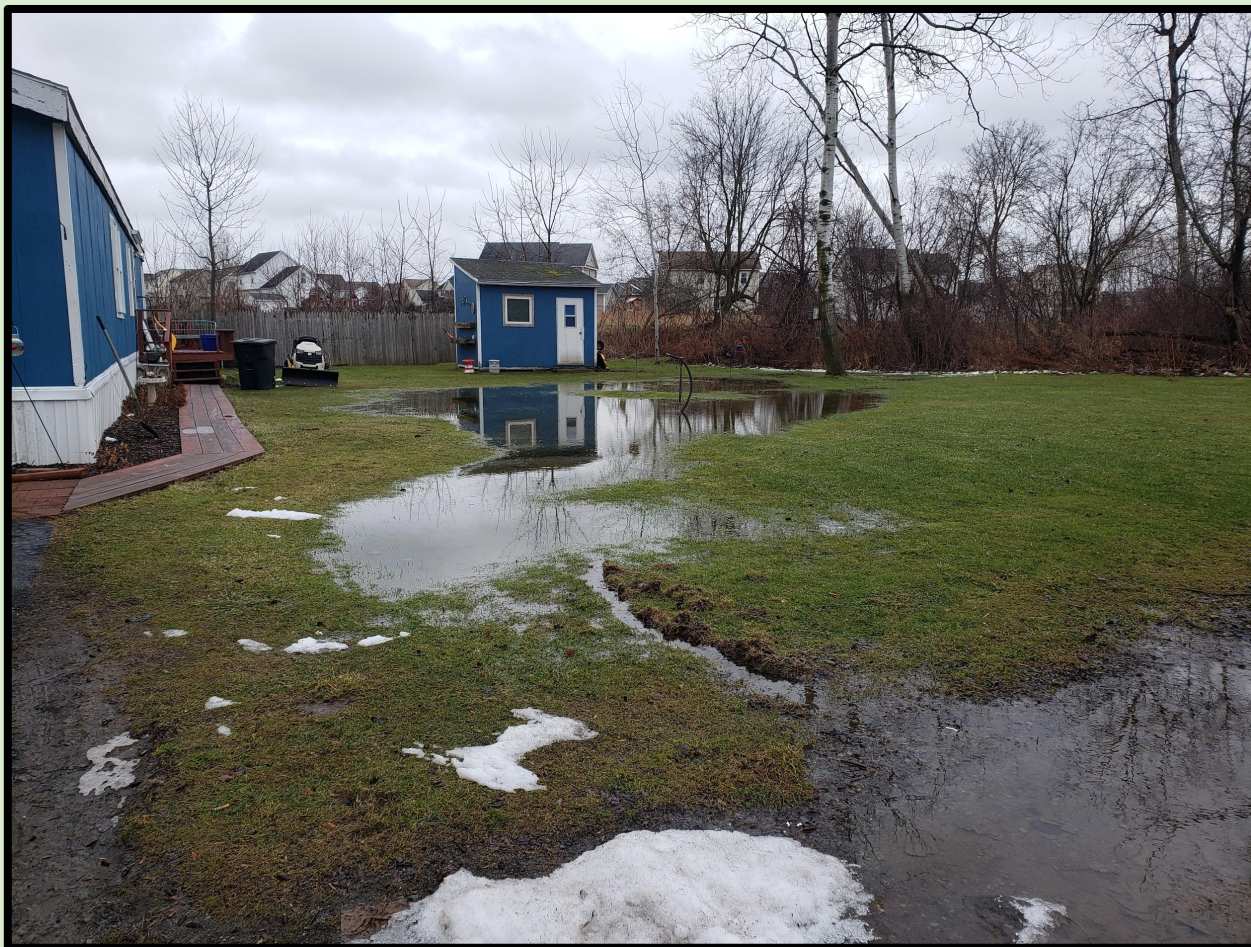
Figure 2: Stagnant water pooling in area of interest. A trench was dug to try to drain the water. The amount of water shown in the Figure represents a relatively low pooling depth, as it can get much deeper (2020).

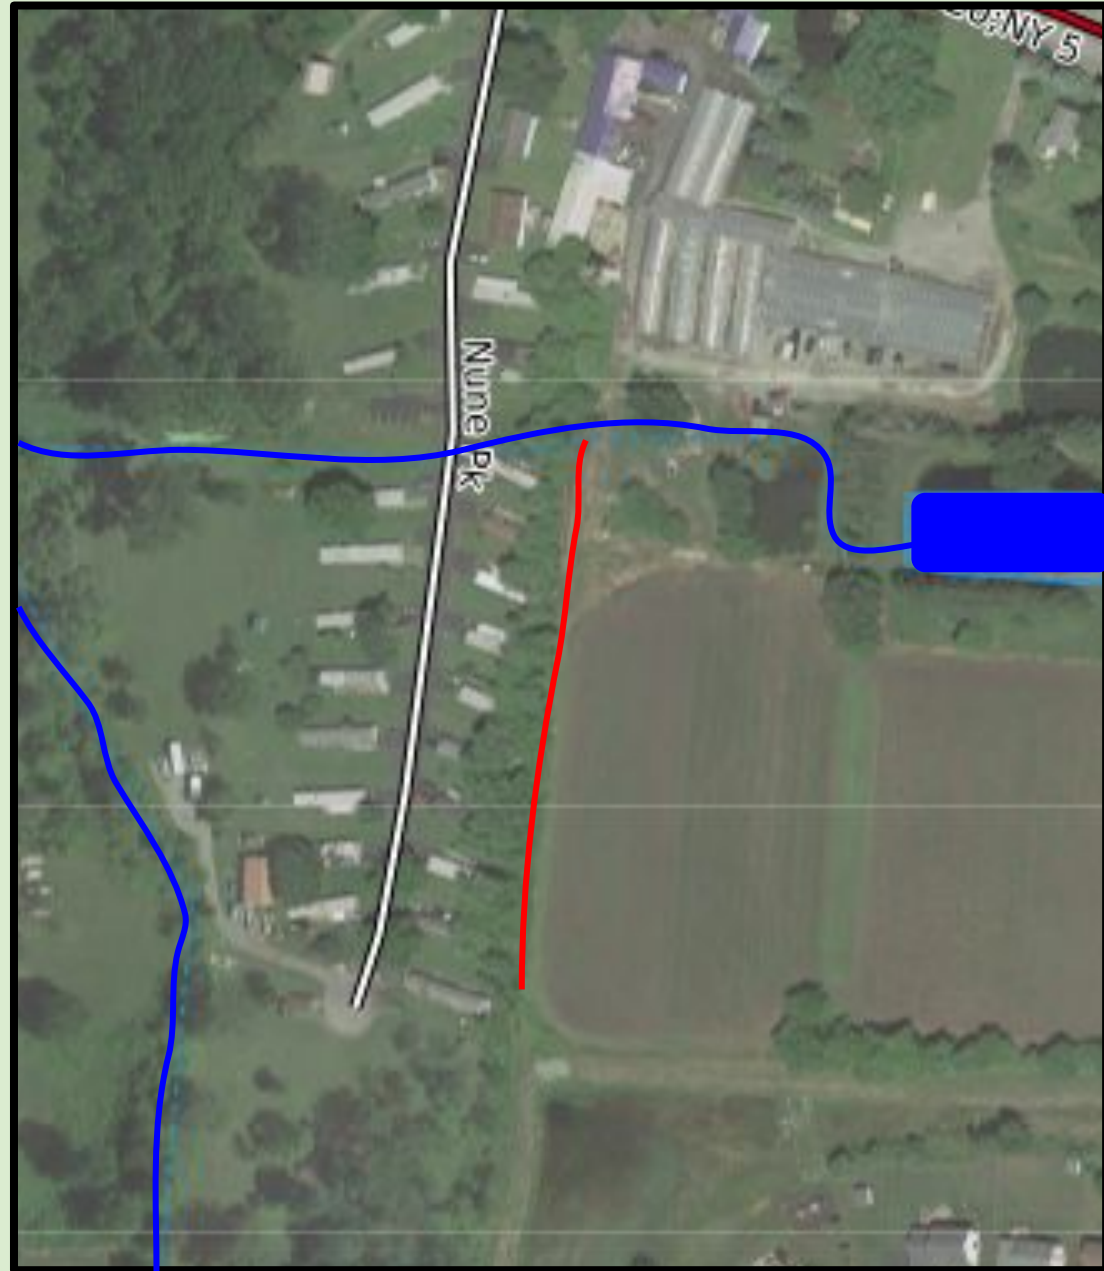
Figure 3: Aerial photograph of Nune Park. Outlined are the streams and ponds (blue) and the ditch (red) (Caltopo, 2020).

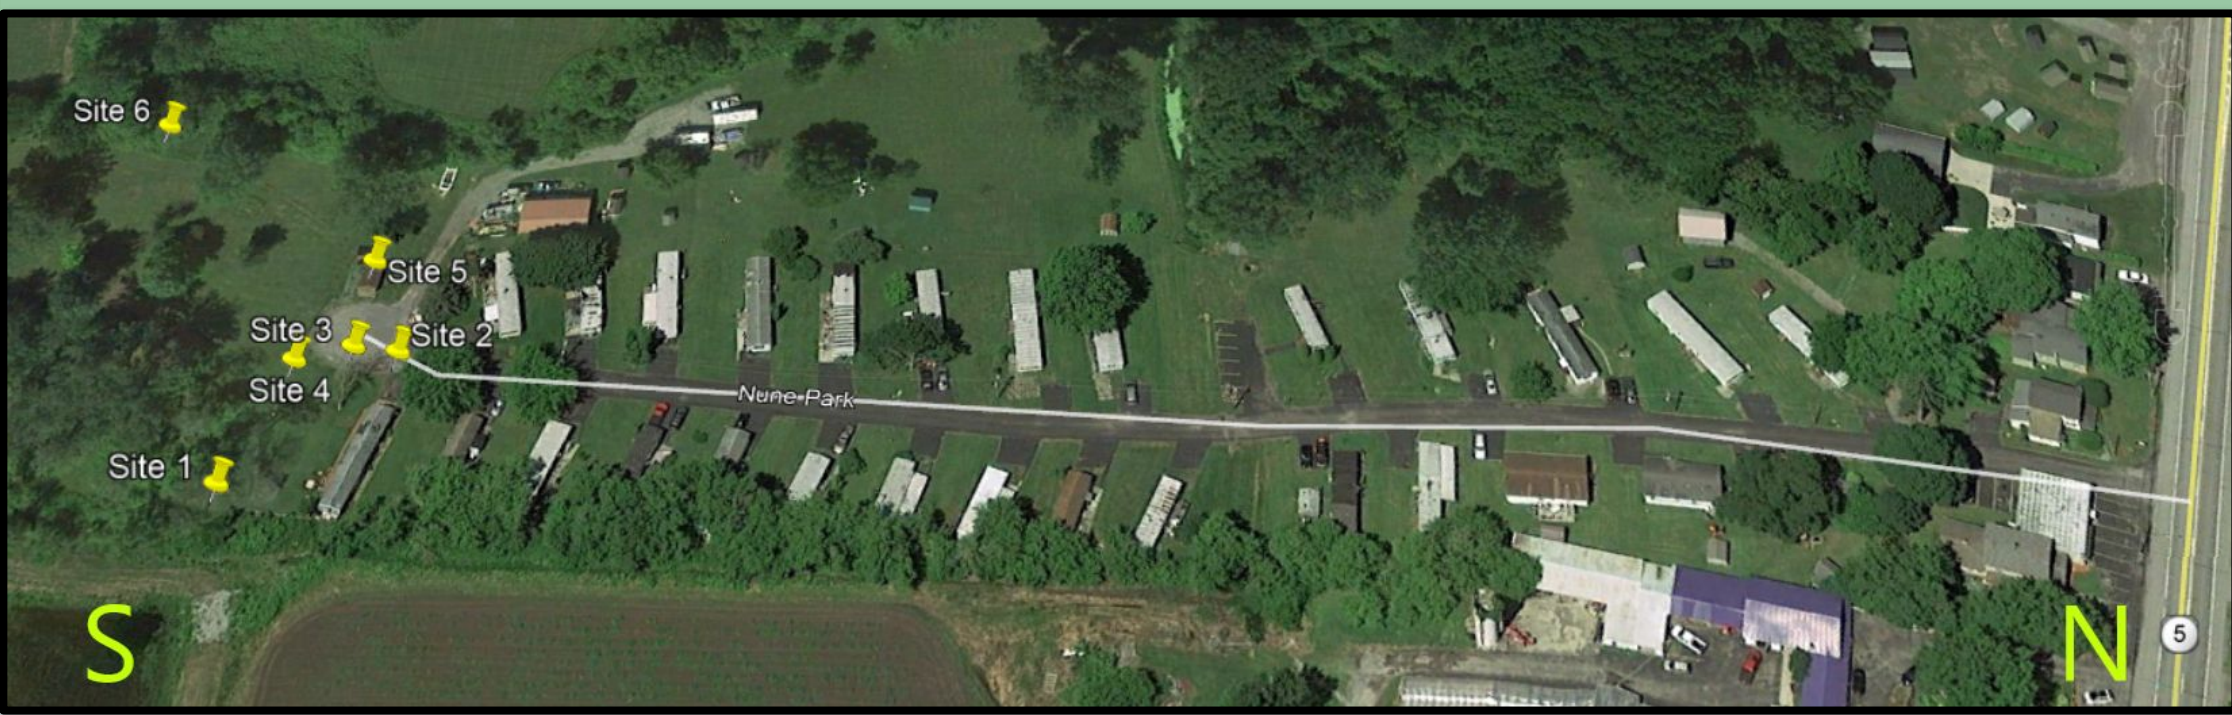
Figure 4 (Left) Nune Park with the six sampling sites marked at the south end. (Google Earth Pro, 2020)

Soil samples were taken from six sites across the south end of the park (Fig. 4). The sites were chosen to represent the variety of locations where flooding occurs. At each site, a hole of at least 6 inches was dug and then one shovelful of sediment was collected from the edge of the hole. The samples were mixed together to create a composite sample, representative of sediment in the flooded area.

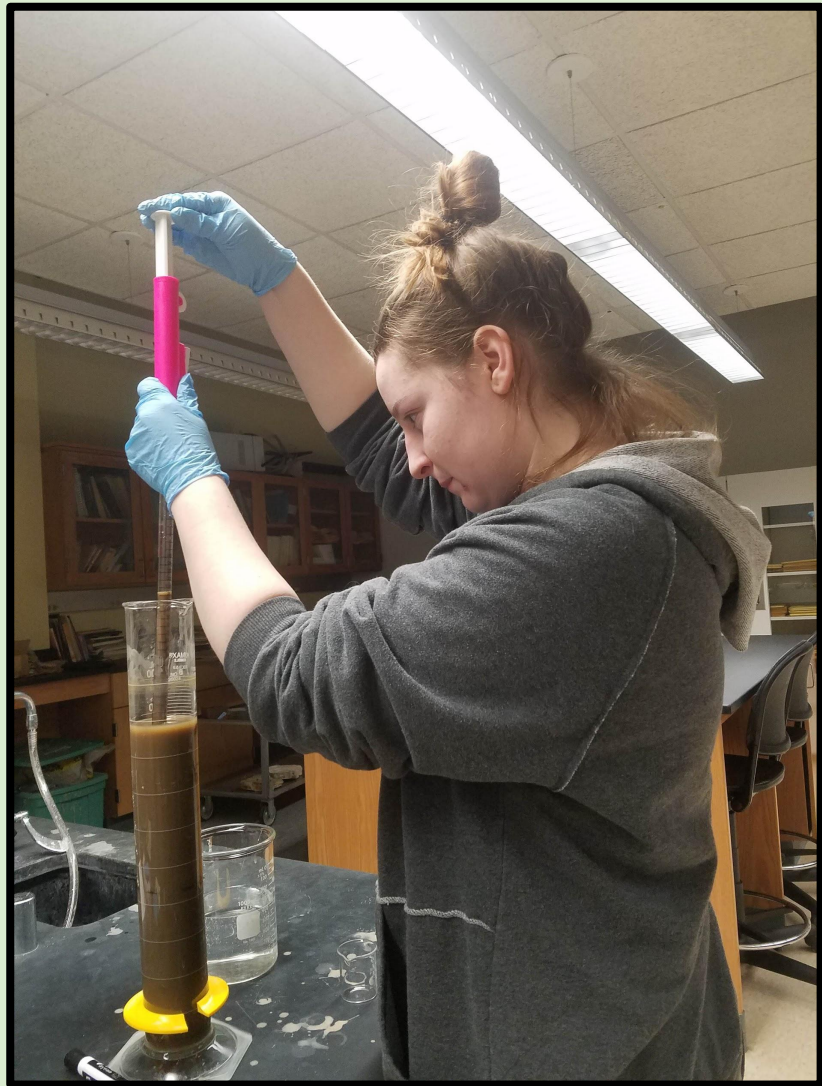
Figure 5 (Right) Pipette extraction being done by Maddy Waldock in the wee hours of the night (2020).

Initial sieving was done to separate the mud and the sand in the composite. To do this, a dispersant was added and the mixture was sonicated. This ensured that the smaller particles did not flocculate. The mixture was then sieved at 63 μm over a 1000 mL graduated cylinder. Smaller grains (mud) went through the sieve and collected in the cylinder, while the larger grains were separated out. The larger grains were dried in an oven. The larger grained material was then dry sieved to separate into seven different sizes and weighed individually. A pipette analysis was done on the mud, which entailed stirring the mixture in the graduated cylinder after which a specific amount was extracted at predetermined time intervals. This method provides a means of collecting the varying grain sizes present as the particles fall out of suspension according to size. Each extraction was then dried in the oven, and subsequently weighed individually as well. The recorded masses were used to determine relative grain size and sorting of the composite sample.

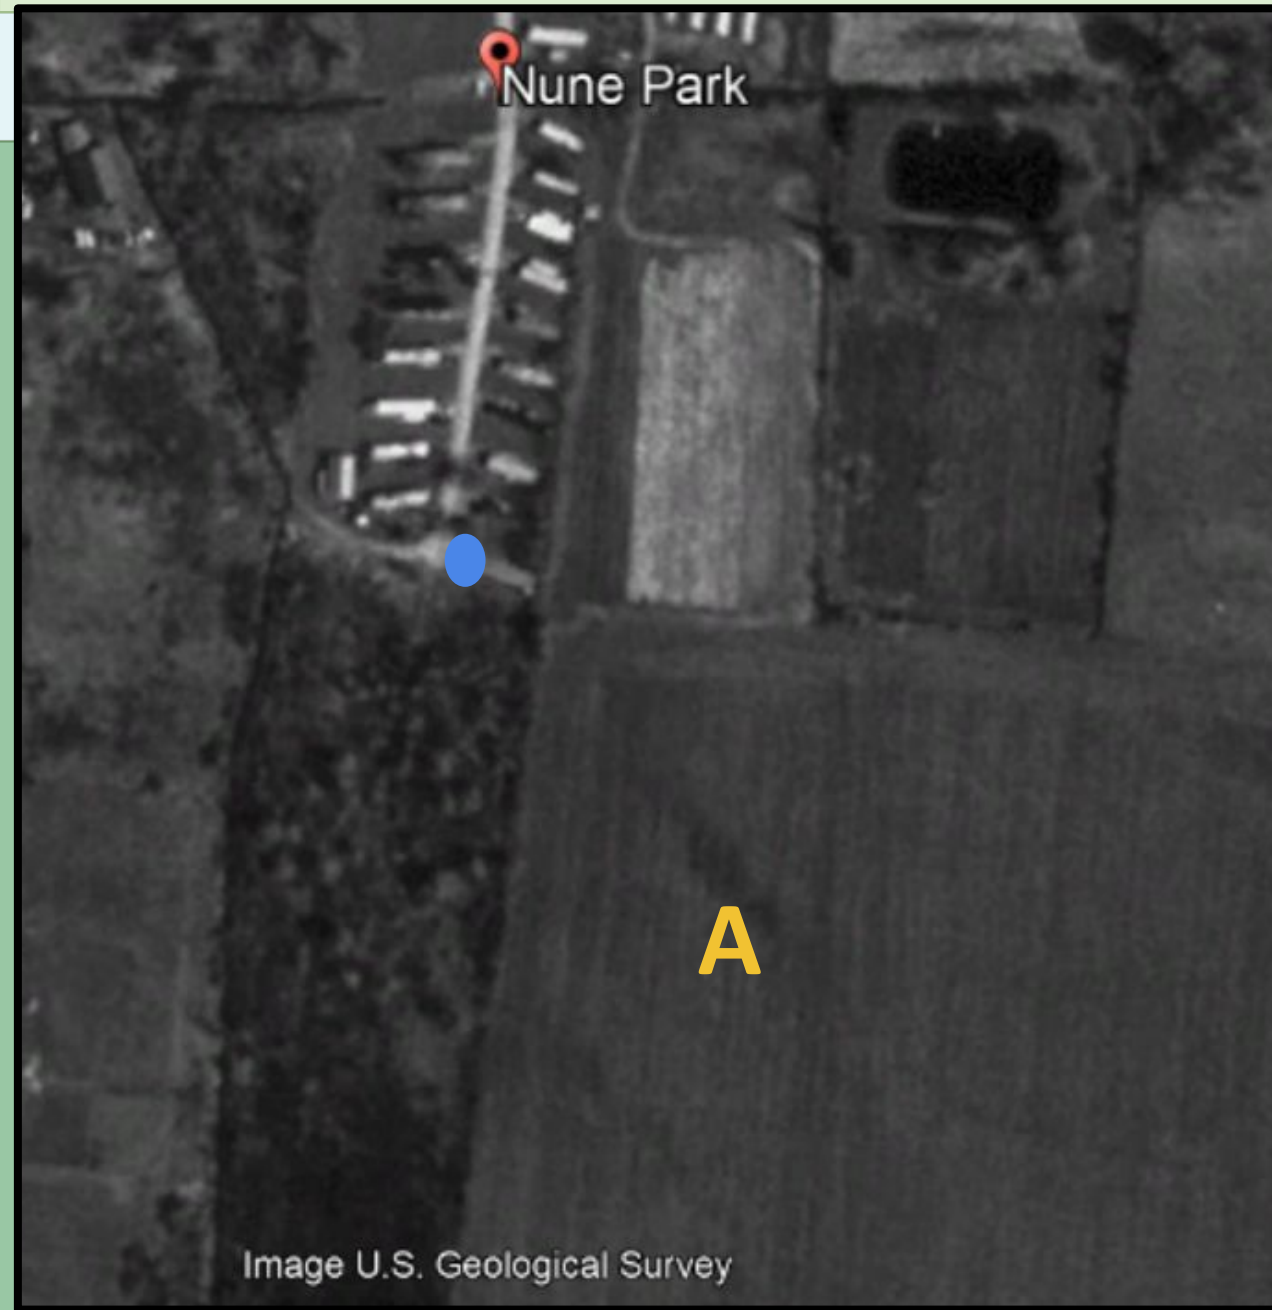
Figure 6: Satellite image of Nune Park in 1994. Blue dot is study area (Google Earth, 2020).

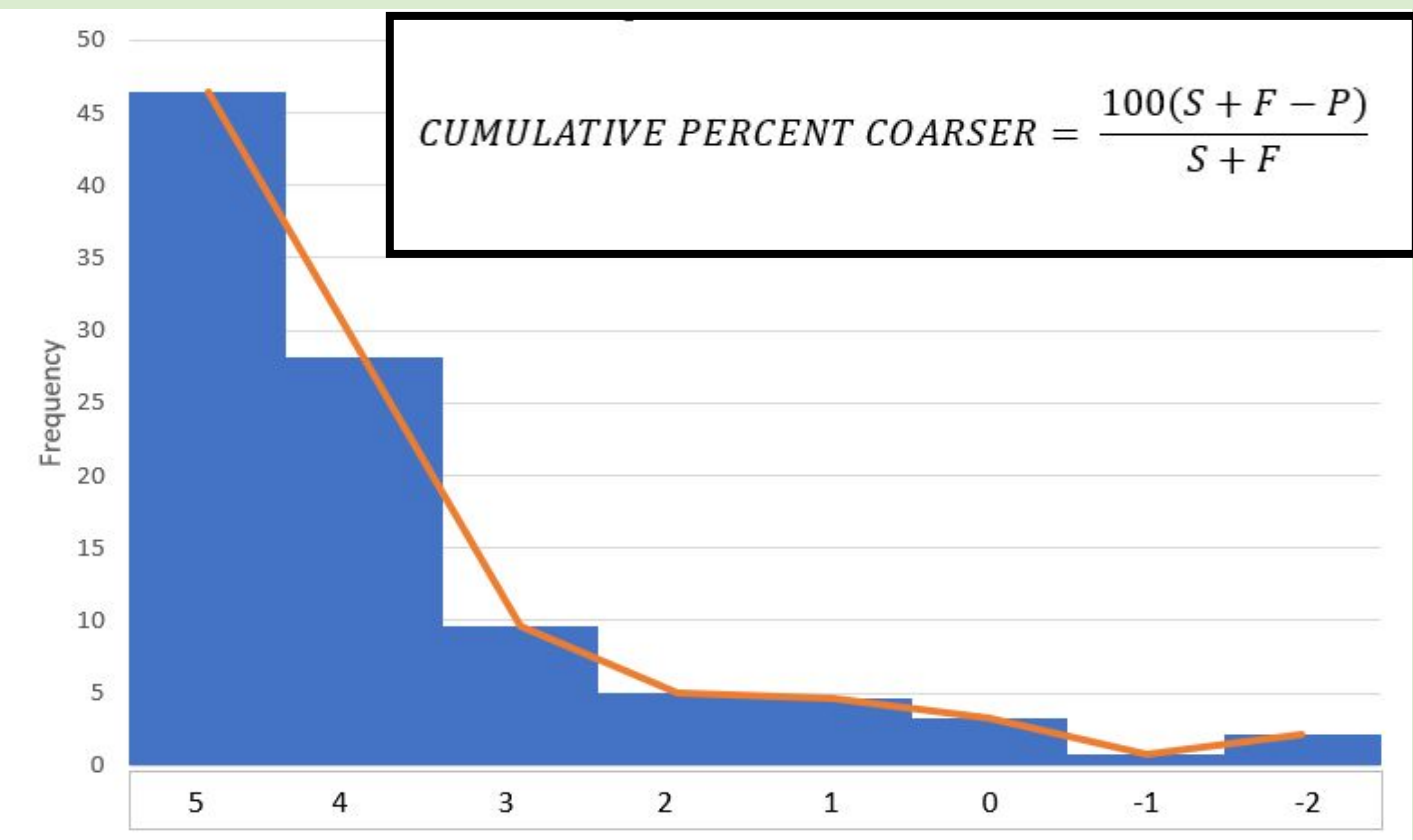
Roughly 46.5% of the composite sample was smaller than 63 μm , meaning almost half of the sample was mud (Fig. 8). Mud-sized particles tend to flocculate (clump), which can hinder drainage. The frequency curve generated from the mass of sieved materials suggest poor sorting (Fig. 8), which can also hinder drainage. The curve does not account for many larger clasts that were pulled from the composite sample, so as to not damage any of the sieves. These excluded clasts would contribute to higher frequencies at lower phi sizes, again indicating poor sorting. Collectively, the sediment analysis suggests that the soil is prone to pool water.

Figure 8 (Right): Grain size frequency curve that illustrates sample sorting, with phi units on the x-axis, higher numbers representing smaller grains.

The flooding problem at Nune Park is likely due to changes in land use up-gradient from the study area coupled with the soil conditions at the site. Runoff towards the study area has increased because of the presence of the new neighborhood. The water is pooling in Nune Park because of the poor sorting and dominance of mud-sized particles in the local soil. The most practical solution to minimize future flooding would be to ditch the area between the two neighborhoods and direct runoff into the stream and away from Nune Park. versed, the most practical response to this should be a re-gradation of the sediment in the area, so as to remediate the current drainage issues.
