# Geomorphic Characteristics of Canadice Lake, NY, Watersheds and the Anthropogenic Effects on Watershed Output and Sensitivity

Carla Crampton, Dr. Nicholas Warner, Department of Geological Sciences, SUNY Geneseo, 1 College Circle, Geneseo, NY, 14454, [cmc61@geneseo.edu](mailto:cmc61@geneseo.edu)

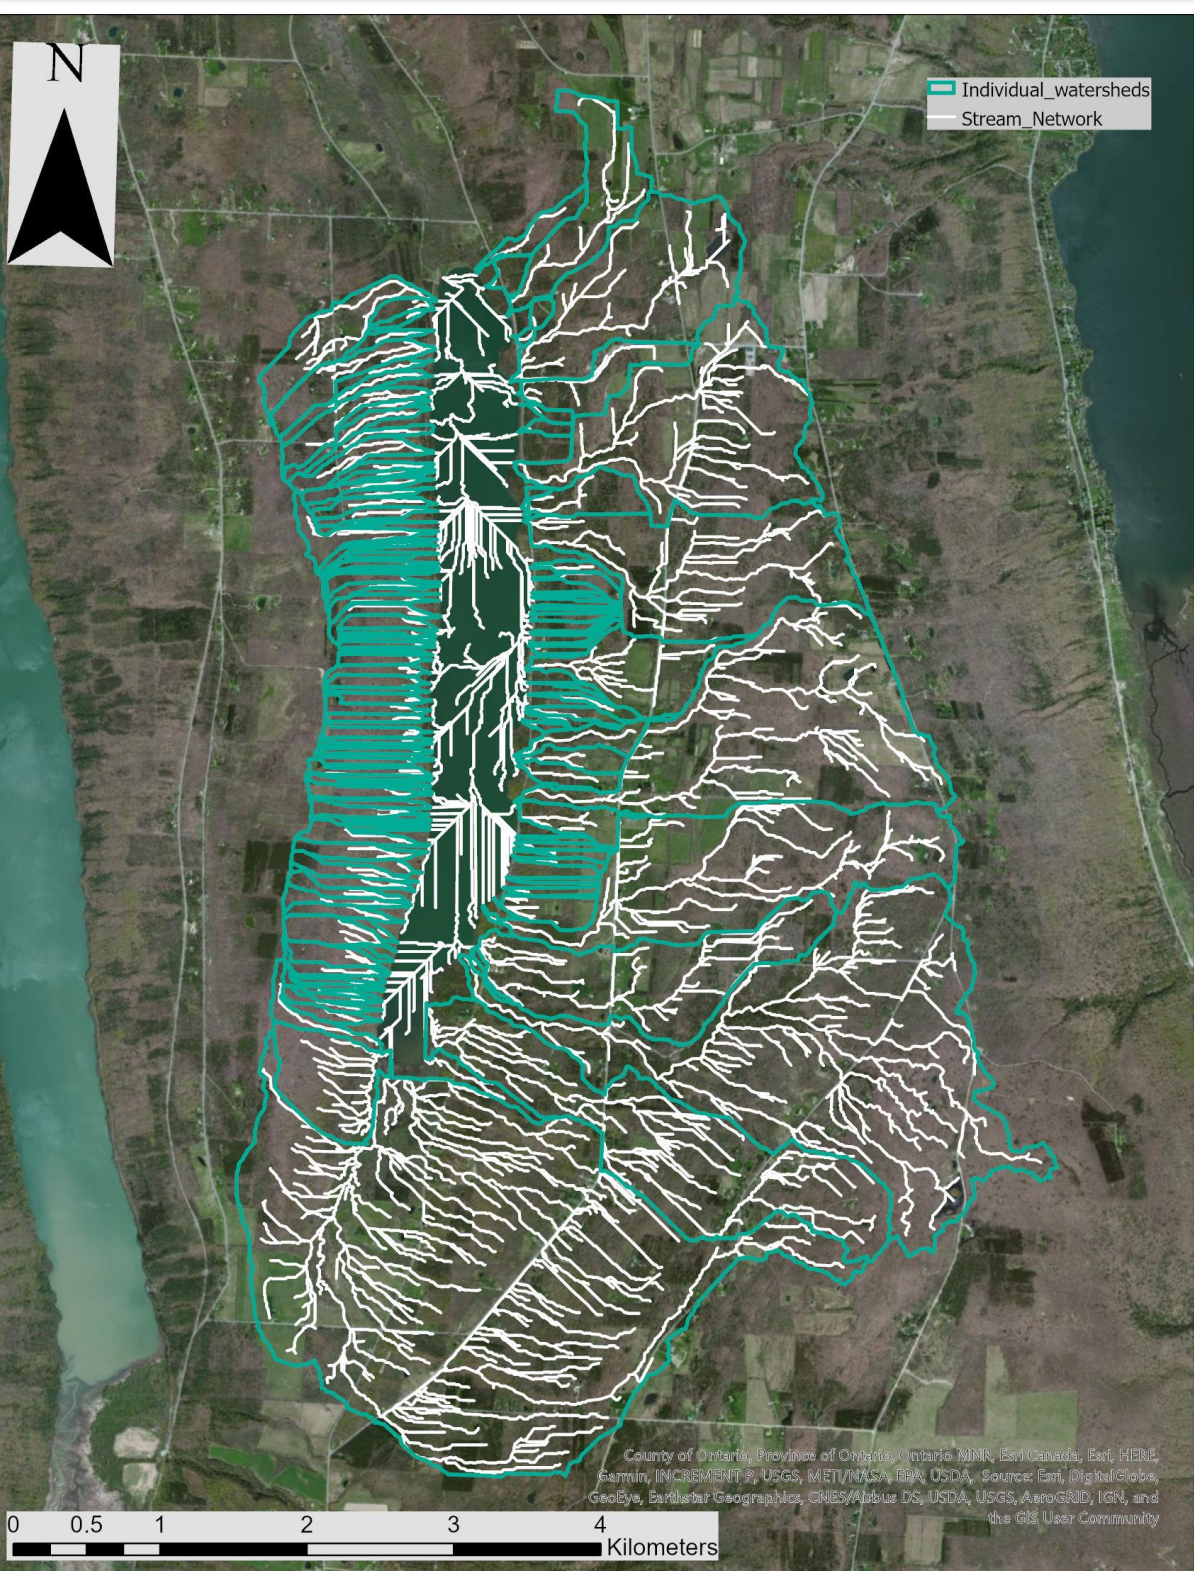
**Figure 4.** Stream networks and individual watersheds from flow accumulation grid and pour points

**Methods**  
The LiDAR DEMs were chosen from <https://gis.ny.gov/elevation/lidar-coverage.htm>. The Livingston and Ontario county DEMs were mosaiced together at 5m per pixel, datum: NAD 1983 UTM Zone 18N. Using a flow direction and accumulation grid, stream networks were extracted in ArcGIS Pro using an upstream contributing area threshold of 0.01m<sup>2</sup>. By snapping pour points to the end of each river that entered the lake, the hydrology watershed tool constructed individual watersheds. This raster format file was converted to vector format. Land use areas and roads were mapped using the ESRI World Imagery Layer at a scale of 1:8,000. Each individual watershed polygon was used to clip the land use area polygons and road polylines to evaluate human impact. Land use area and road density were calculated for each watershed. Using Excel, the watersheds with the most human impact by percent area and by total area were calculated. These data were inserted into the attribute tables for individual watersheds and a graduated color ramp was chosen to display the relative area coverage and road density.
